Raseinių Švč. Mergelės Marijos Ėmimo į dangų bažnyčios šventorius

The churchyard of the Church of the Assumption in Raseiniai

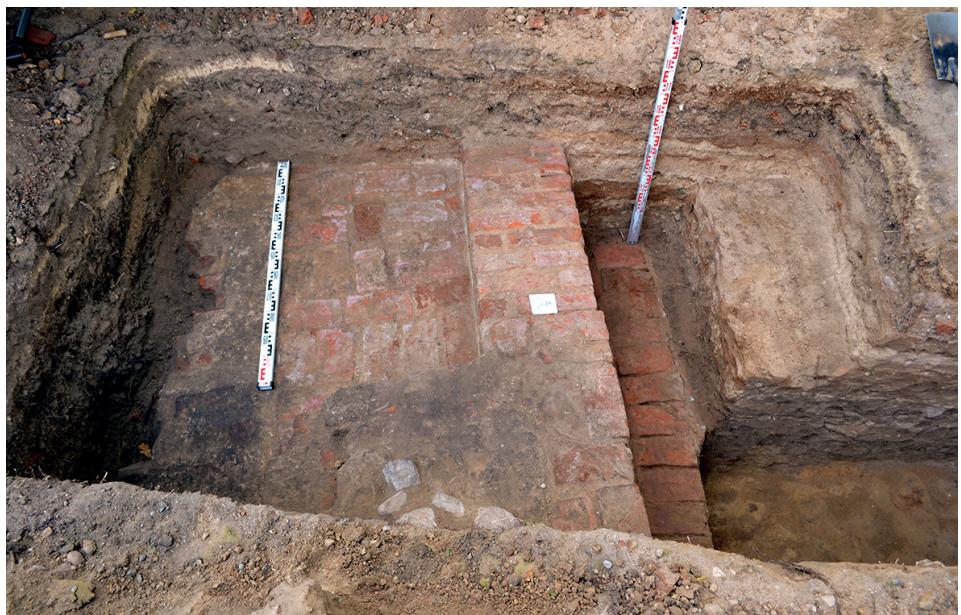
1 pav. Buvusios galerijos pamatai. J. Račo nuotr.

Fig. 1. The foundation of the former gallery.

pločias iki 7 m². Iš atsidengusio vaizdo galima numanyti, kad buvo aptiktos buvusios galerijos, ėjusios nuo bažnyčios iki vienuolyno, pamatas (1 pav.).
